# McCORMICK AND BAXTER CREOSOTING COMPANY SUPERFUND SITE PORTLAND, OREGON

## **Pictorial Overview**

**Site Discovery to Site Cleanup  
(1989 through 2006)**

(February 2006)

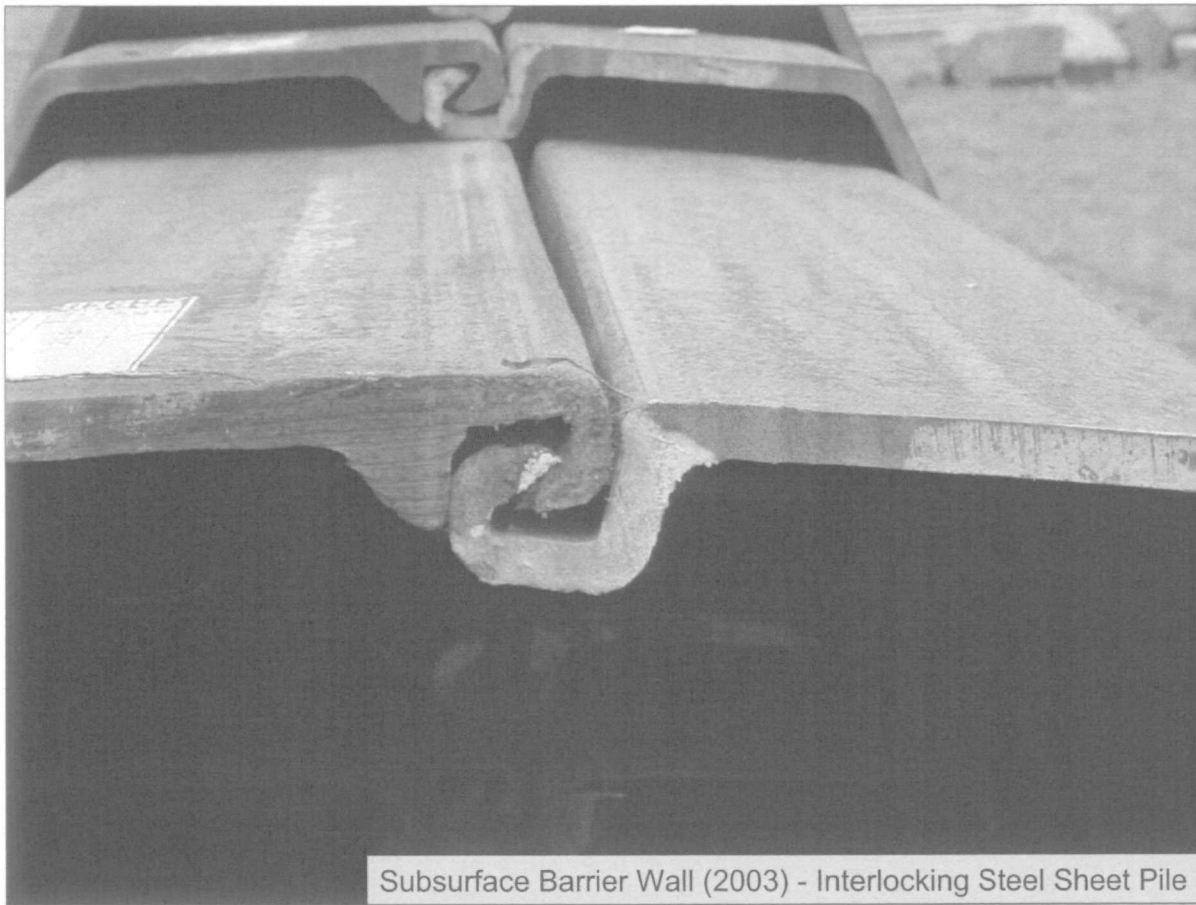
Subsurface Barrier Wall (2003) - Interlocking Steel Sheet Pile

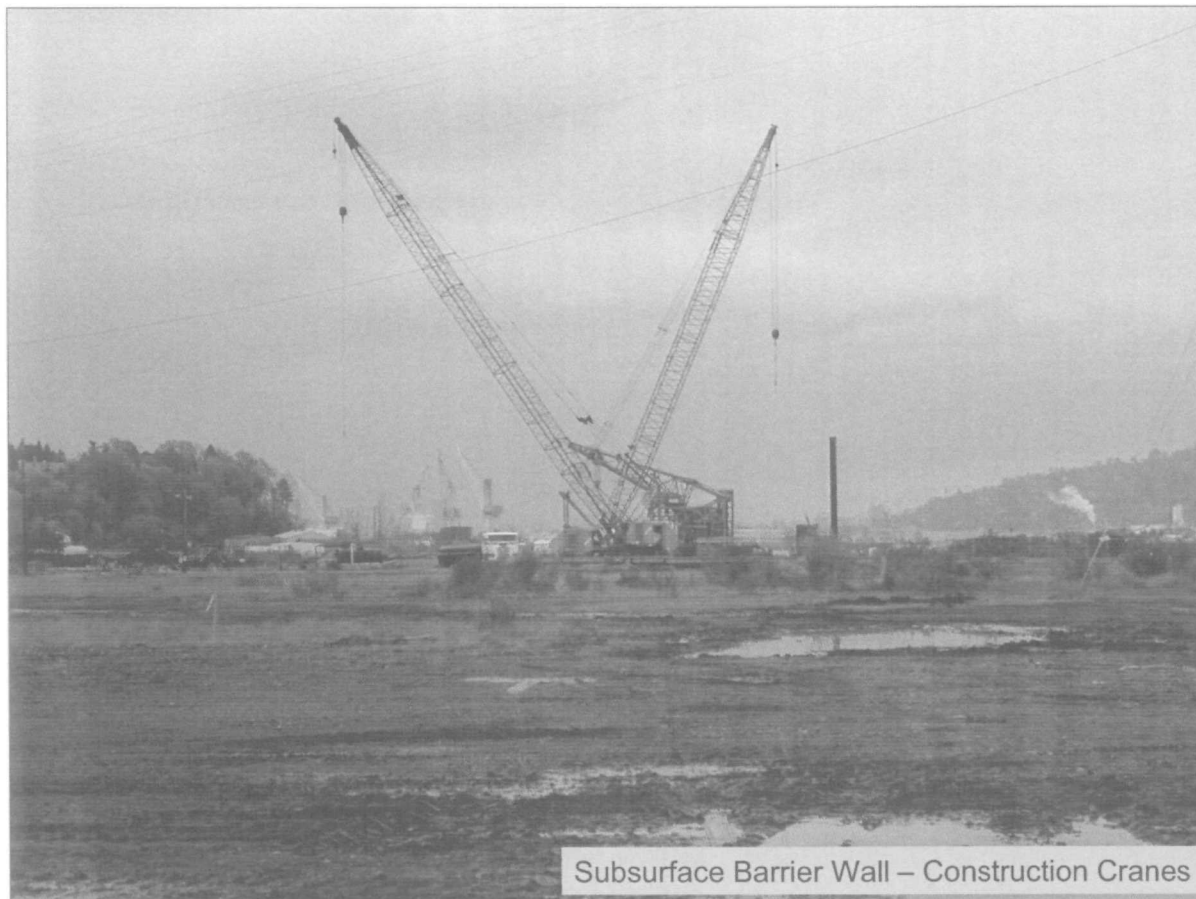
Subsurface Barrier Wall – Construction Cranes

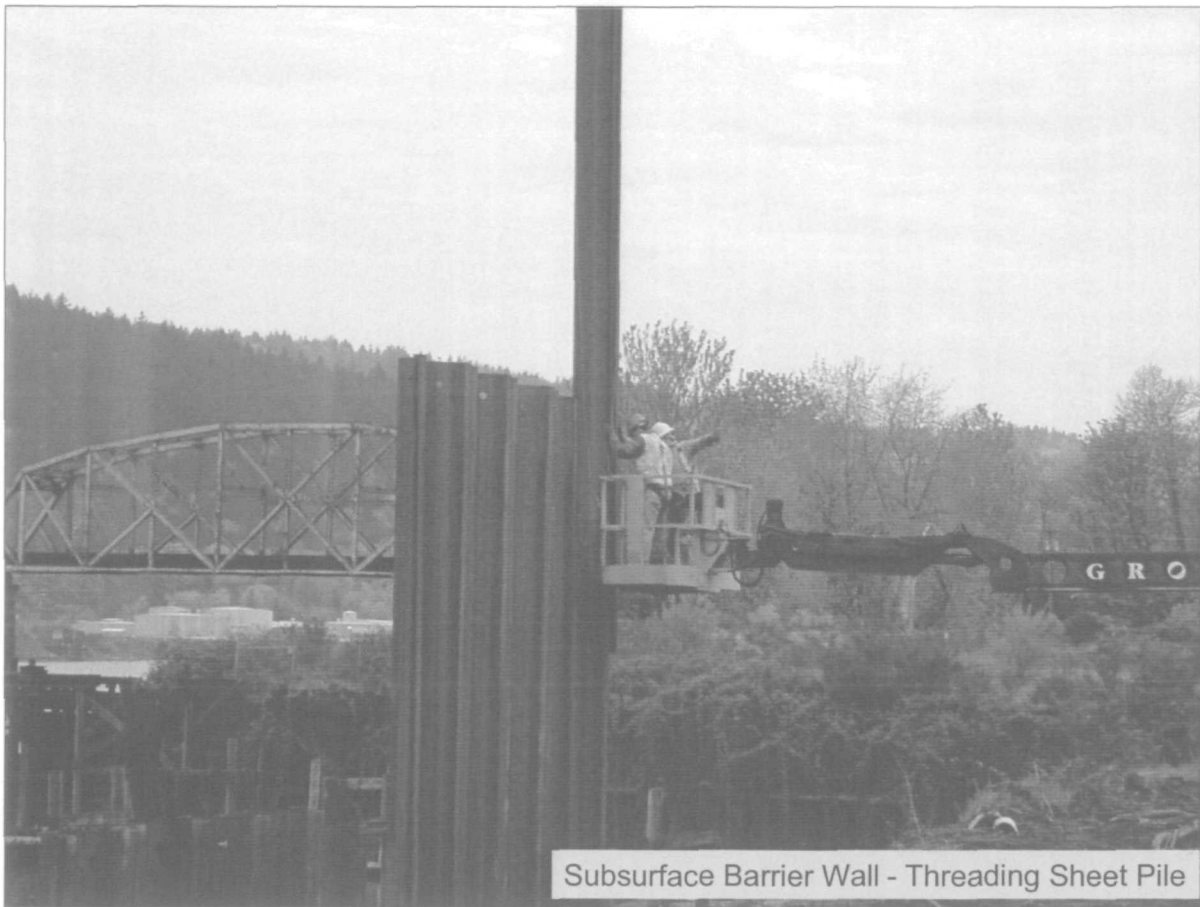
Subsurface Barrier Wall - Threading Sheet Pile

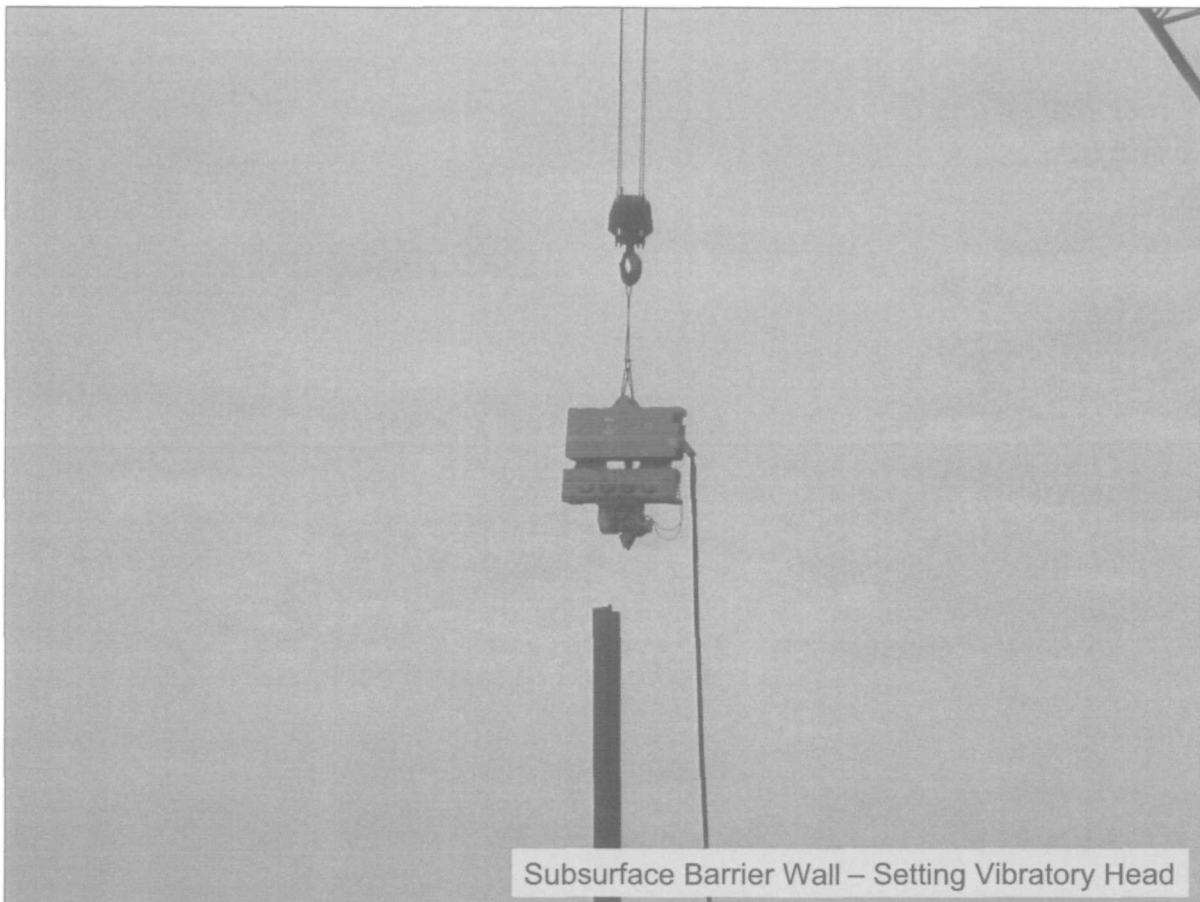
Subsurface Barrier Wall – Setting Vibratory Head

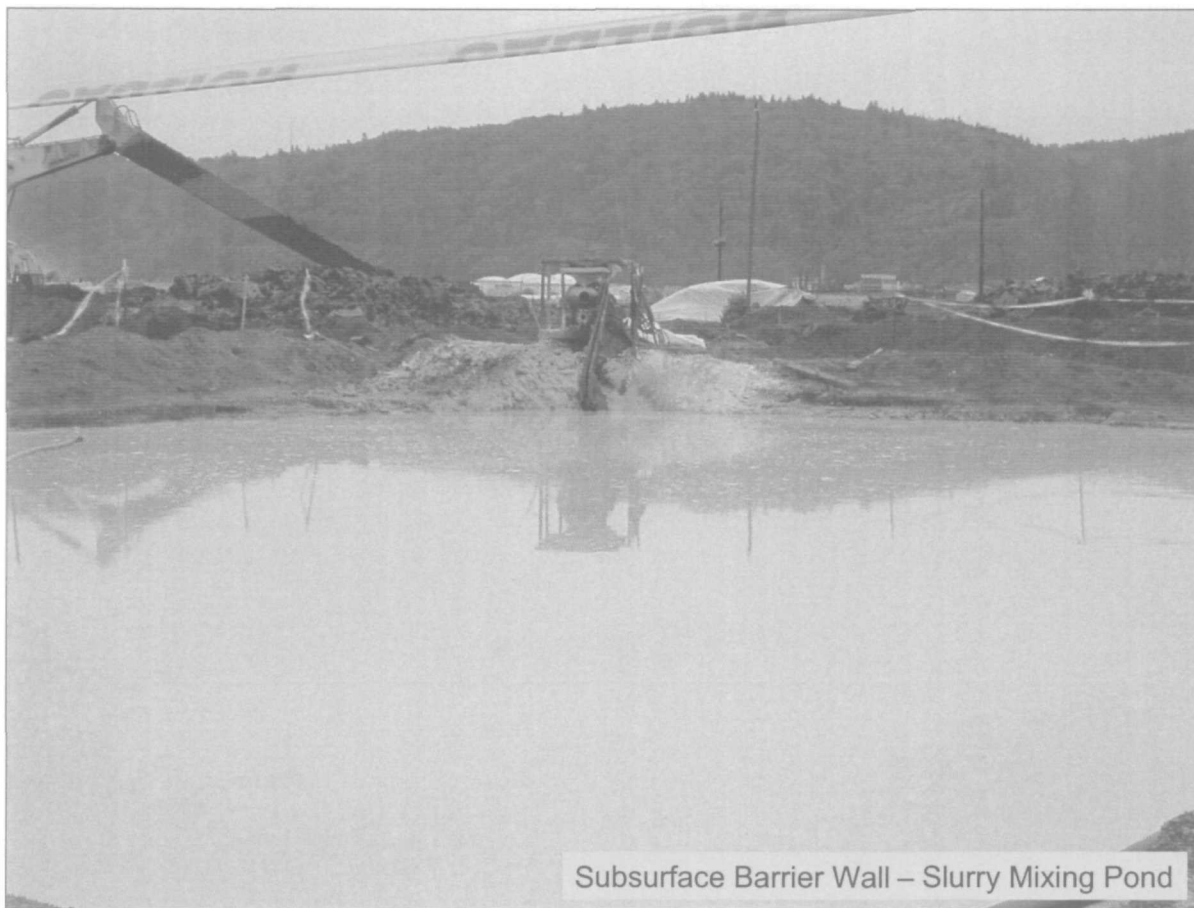
Subsurface Barrier Wall – Slurry Mixing Pond

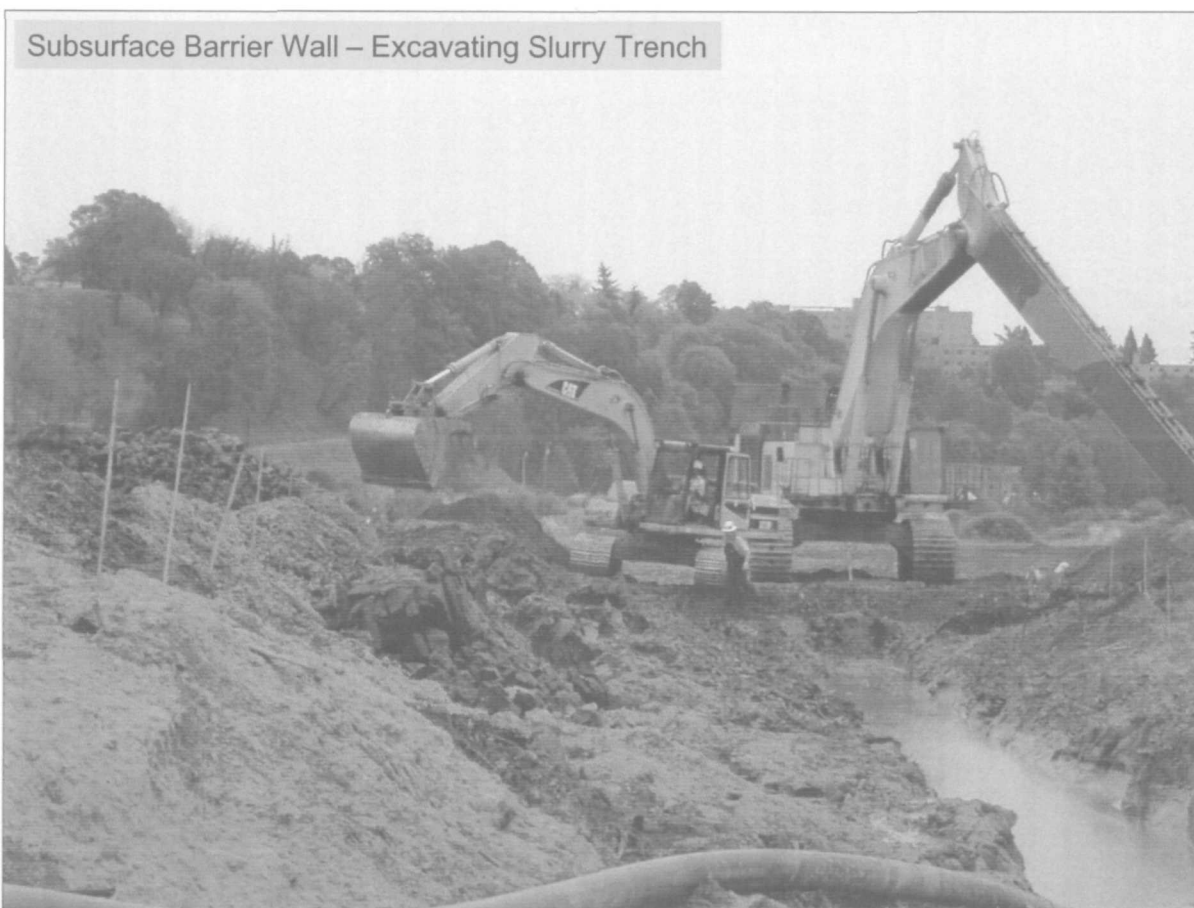
Subsurface Barrier Wall – Excavating Slurry Trench

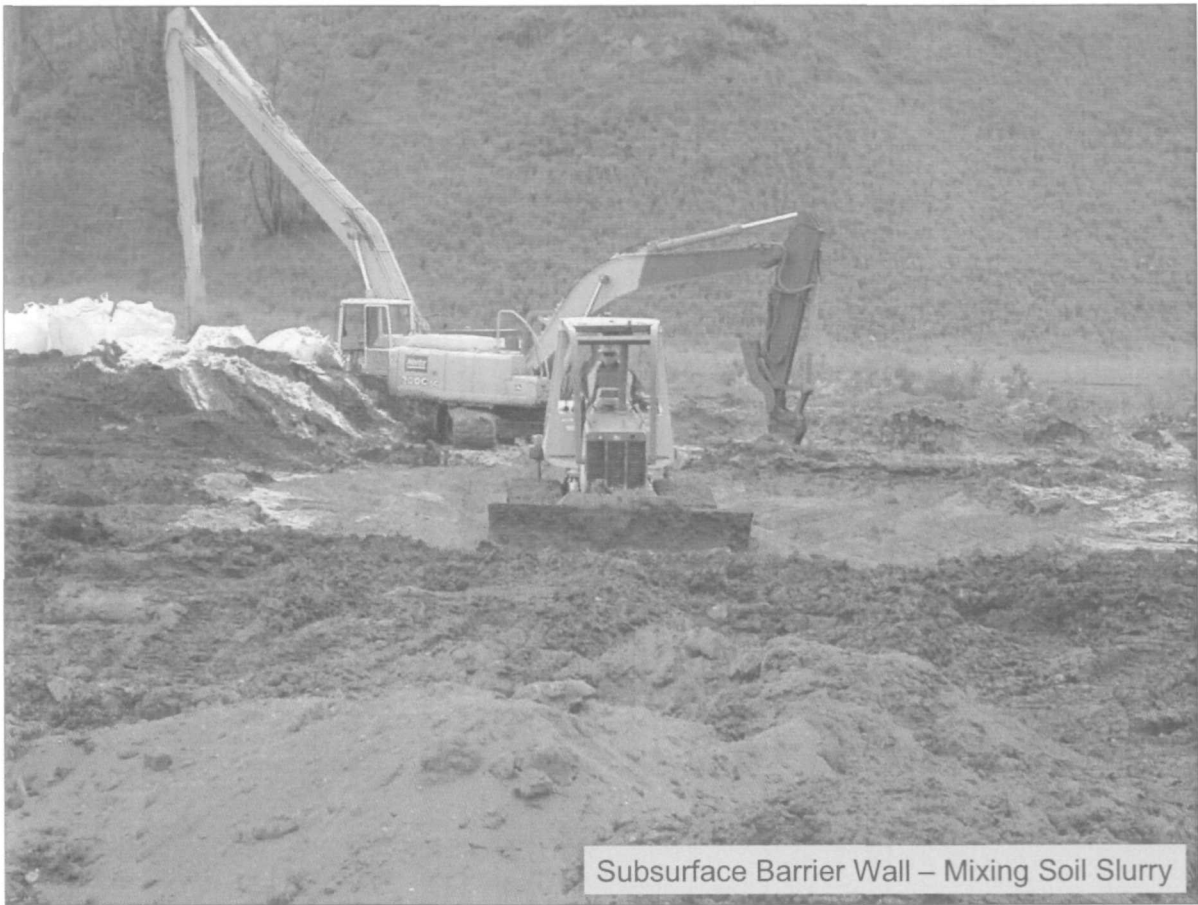
Subsurface Barrier Wall – Mixing Soil Slurry

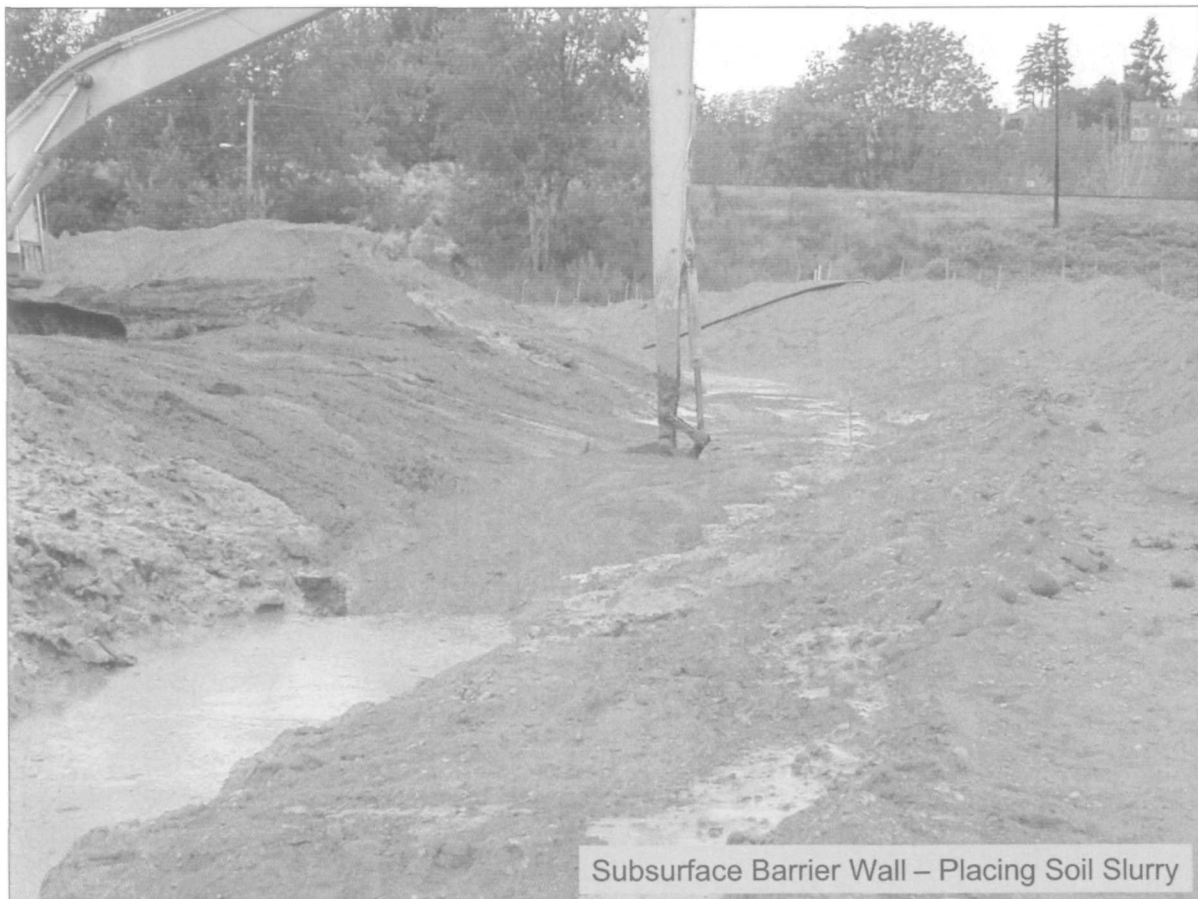
Subsurface Barrier Wall – Placing Soil Slurry

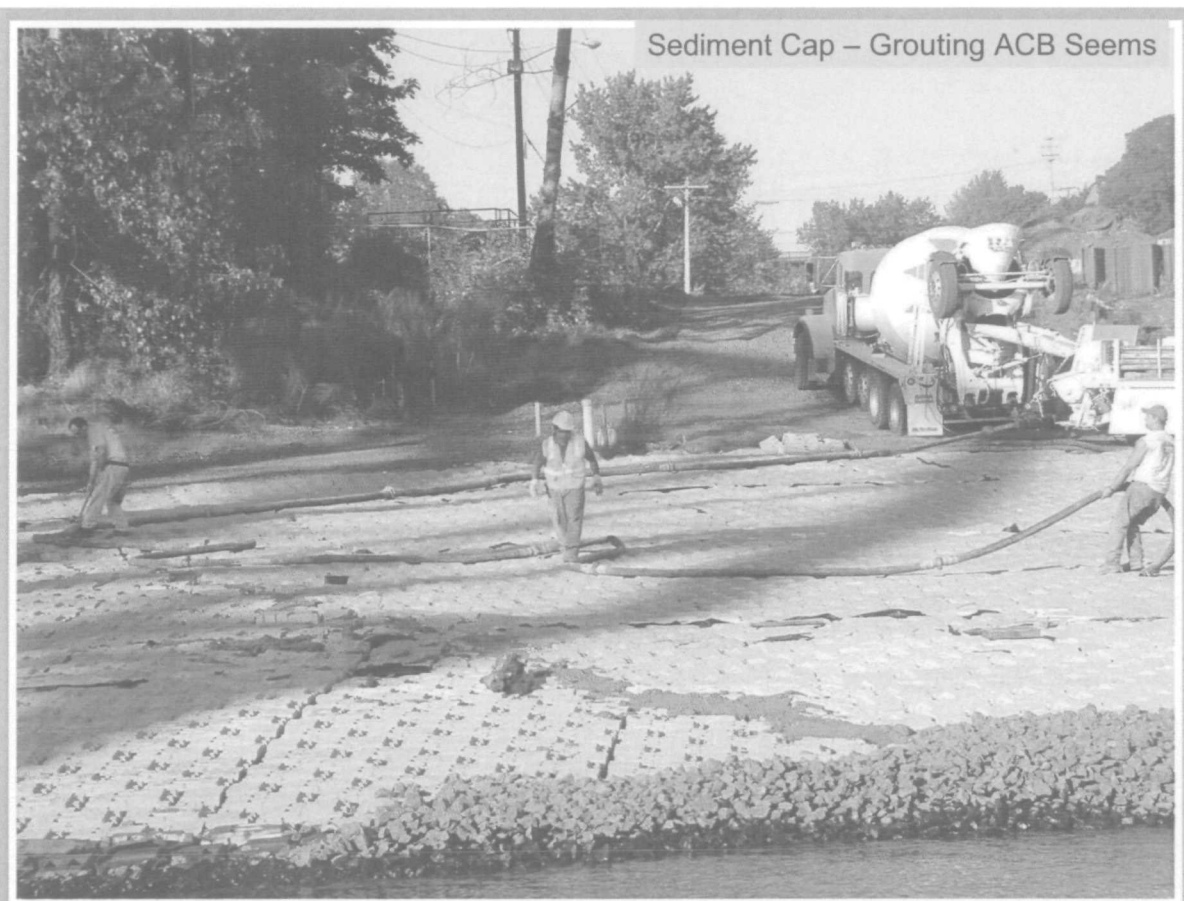
Sediment Cap – Grouting ACB Seams
